# INSTALLATION RESTORATION PROGRAM

# PRELIMINARY ASSESSMENT/ SITE INSPECTION REPORT

LOVELL FIELD AIR NATIONAL GUARD STATION 241<sup>st</sup> ELECTRONIC INSTALLATION SQUADRON TENNESSEE AIR NATIONAL GUARD CHATTANOOGA, TENNESSEE

**JULY 1995**

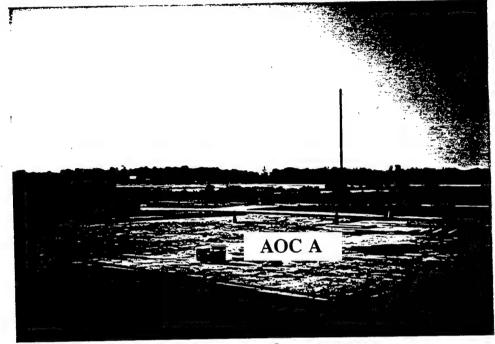
FIGURE A-4
Area of Concern A (located behind Building 100)

AOC A is located behind Building 100 at the Station. The area is covered mainly with gravel and is used as a parking area. Oil stains were visible on the gravel from the parked vehicles. The analytical results are presented and discussed in the following subsections.

facing northwest

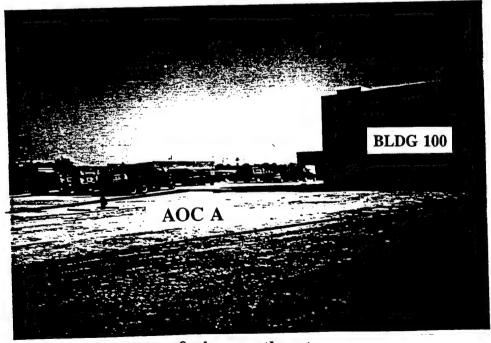
FIGURE A-5
Area of Concern A (located behind building 100)

facing northeast
